| Ride distributed by:<br>Zamperla SPA<br>Via Mte Grappa 15/17<br>36077 Altavilla Vic.na<br>ITALY<br>Phone: +39 0444 998 400<br>Fax: +39 0444 573 720 - e.mail: zamperla@zamperla.it | | | | Bulletin No: 2009 RCTC-02<br>Release Date: June 18, 2009<br>Effective Date: June 18, 2009<br>Supersedes:<br>Completion Date: Immediately<br>Page: 1 of 2 |
| <div style="background-color: red; height: 20px; margin-bottom: 5px;"></div> <h2 style="color: red; margin: 0;">SAFETY ALERT</h2> <div style="background-color: red; height: 20px; margin-top: 5px;"></div> | | | | |
| Ride Name: Twsiter Coaster | | Affected Serial Nos.: All | | |
| Abstract Of Issue:<br>Emphasis on importance of inspection of front and rear axles, part number 9476027035A. | | | | |

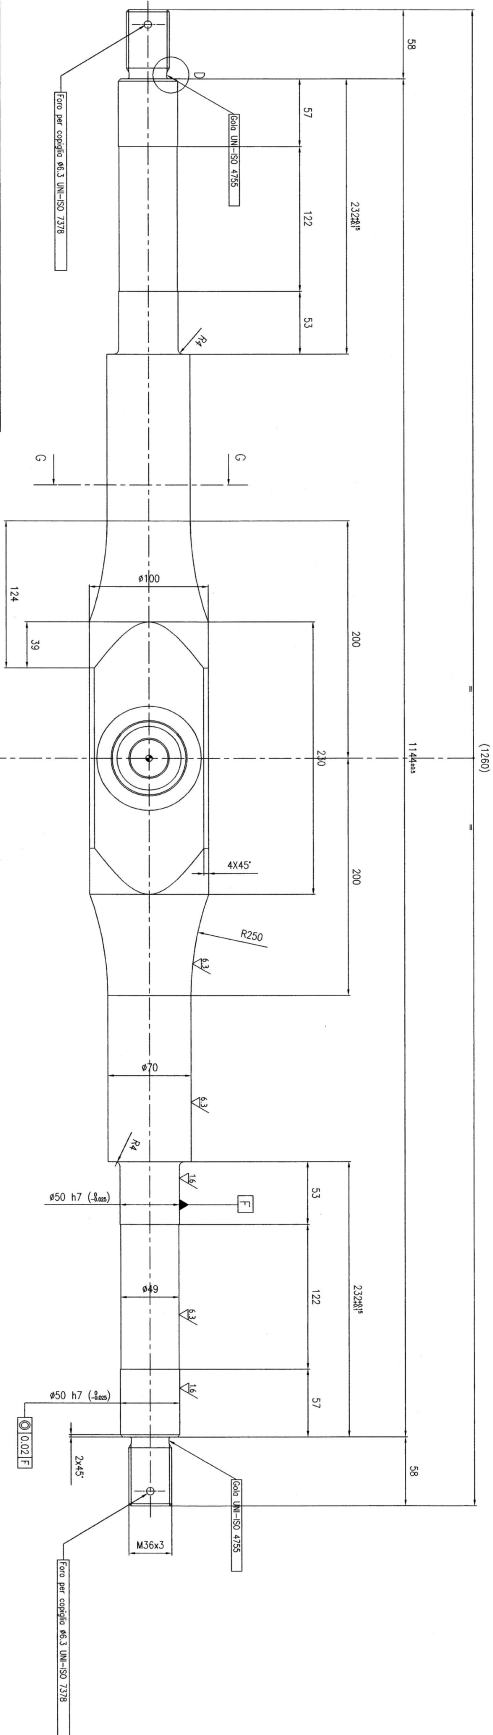
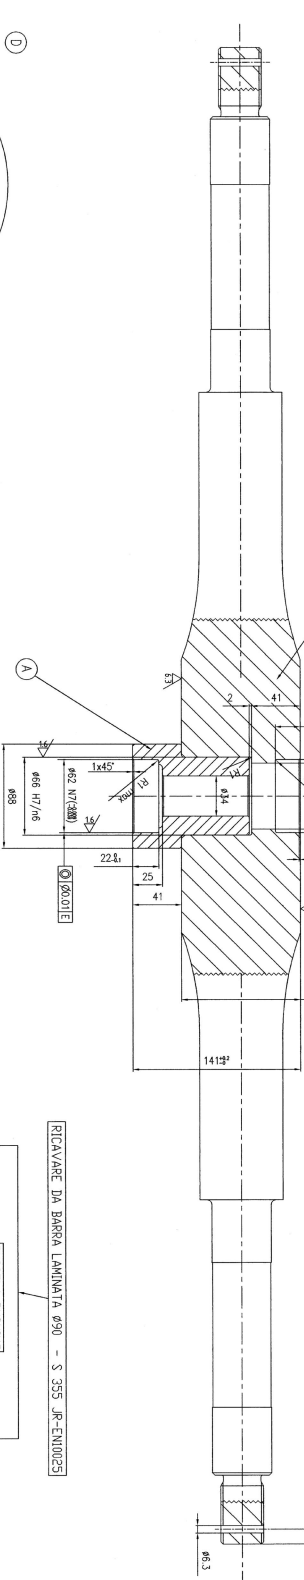
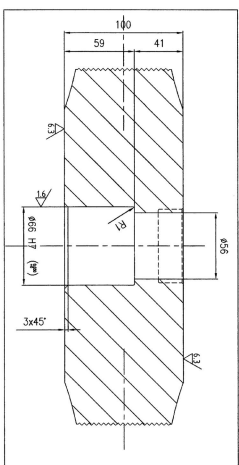
| Reason For Release:<br>An axle failed during operation. To reinforce the need for routine lubrication and non-destructive testing (NDT) of axles. | | | | |
| Detail Of Issue:<br>Preventive maintenance on the axles is critical. Emphasis of inspections needs to be placed in all changes in diameter with highest attention in the area where the axle changes from 50mm in diameter to 70mm. Routine, monthly lubrication of axles as indicated on page 6-40 (page 6-41 in some manuals) in the manual needs to be strictly adhered. | | | | |

| Action To Be Taken:<br>If NDT by means of dye penetrant testing (PT) has not been performed prior to the 2009 operating season, or it has been longer than 3,000 operation hours or 72,000 ride cycles since the last NDT was performed on the axles (part number 9476027035A), then this preventive maintenance must be completed prior to further operation of the axles. | | | | |
| Future Action To Be Taken:<br><br>In addition to the PT performed on the axles, a close visual inspection of the axle must be performed on the axles every time the PT is performed. Emphasis of inspections needs to be placed in all changes in diameter with highest attention in the area where the axle changes from 50mm in diameter to 70mm.<br><br>If any notches, imperfections, unusual wear are noted on the axles, remove axle from operation and send photographs to Zamperla immediately. Zamperla will advise on how to proceed. | | | | |
