| Ride distributed by:<br>Zamperla Spa<br>36077 Altavilla Vicentina<br>via Mte Grappa 15/17<br>ITALY<br>Phone: +39 0444 998400<br>Fax: +39 0444 573720<br>e.mail: zamperla@zamperla.it | | | | Bulletin No: 10-RCTC01<br>Release Date: 01 March 2010<br>Effective Date: 01 March 2010<br>Supersedes:<br>Completion Date: 01 March 2010 | |
| <h2 style="color: blue;">SERVICE BULLETIN</h2> | | | | | |
| Ride Name: Twister Coaster Family | | Affected Serial Nos.: All | | | |
| Abstract Of Issue:<br><div style="text-align: center;">Certain maintenance procedures have been modified</div> | | | | | |

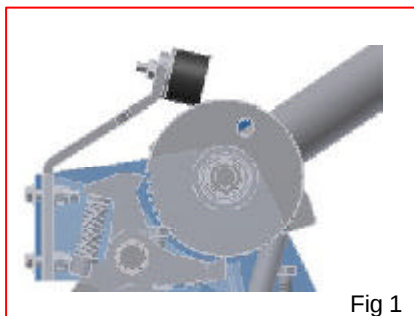
- 1\_ aprire i maniglioni (con chiave in dotazione)
- 2\_ posizionare il maniglione nella posizione "massima apertura (Fig1) con ultimi denti in presa e tirare il maniglione nel verso di apertura .
- 3\_ effettuare la stessa procedura posizionando il maniglione nella posizione intermedia (Fig2) e nella posizione "tutto chiuso".(Fig3)

- 1\_ open the individual T-bars (with the key)
- 2\_ put the individual T-bar in the "max opening" position (Fig. 1) and pull the individual T-bar in the opening sense.
- 3\_ make the same procedure by putting the individual T-bar in the intermediate position (Fig. 2) and in the "all close" position (Fig. 3)

Nel caso venga riscontrato che il maniglione non resta chiuso correttamente bisogna VIETARE la salita ai passeggeri e riparare il maniglione.

If the individual T-bar do not stay correctly closed, it is FORBIDDEN for passengers to get into the ride and you must repair the individual T-bar.
